# ENGINEERING CONDITION SURVEY AND STRUCTURAL INVESTIGATION OF MONTGOMERY LOCKS AND DAM OHIO RIVER

March 1977

Final Report

Prepared for U. S. Army Engineer District, Pittsburgh  
Pittsburgh, Pa. 15222

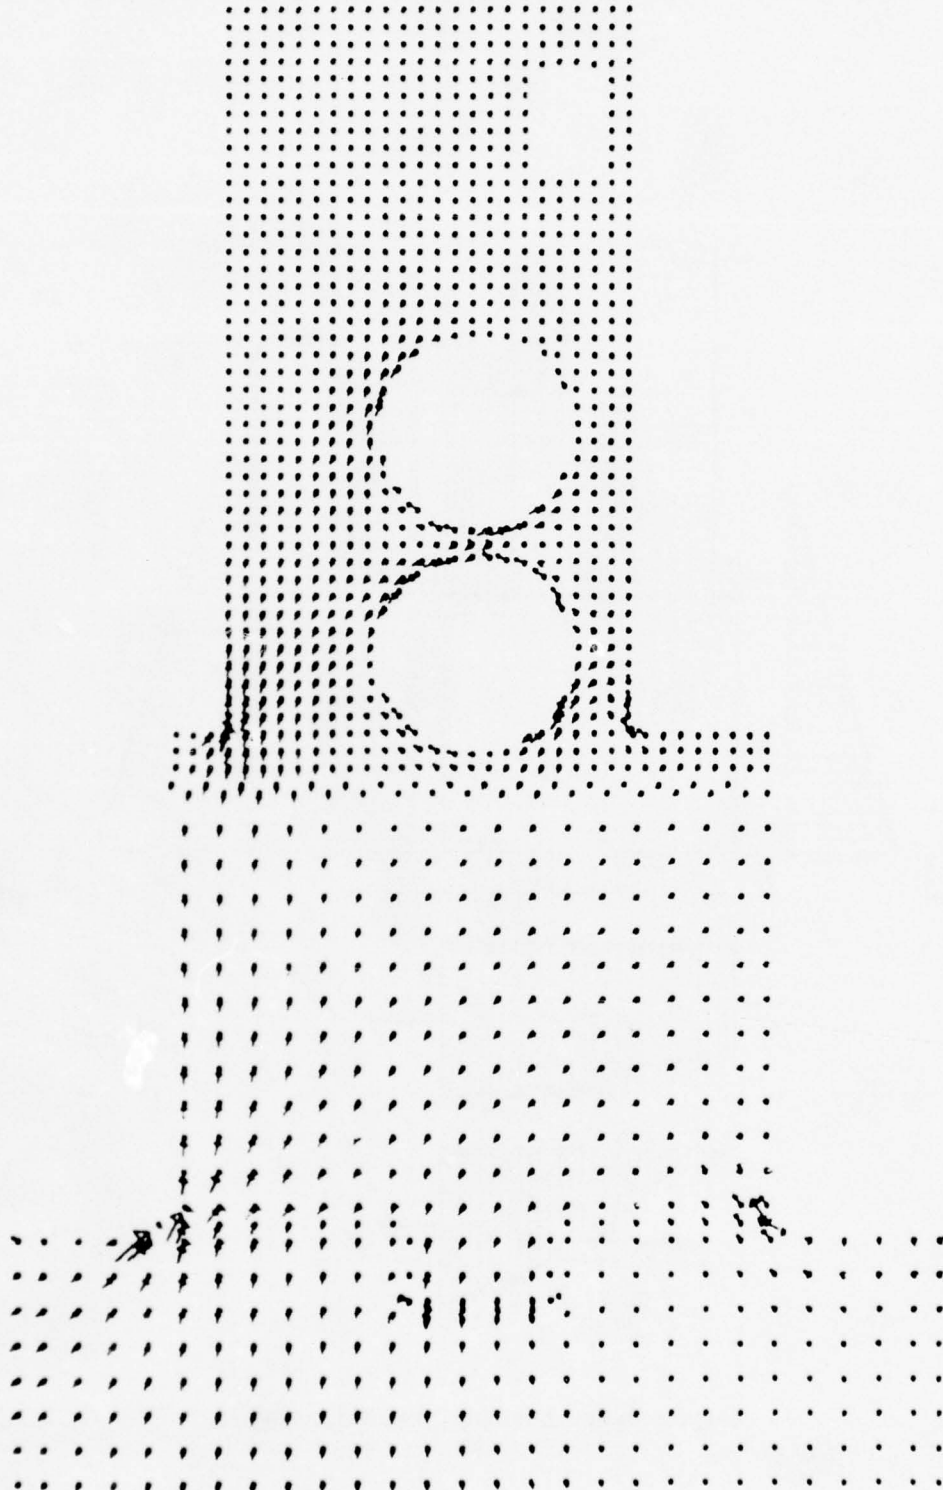
Figure 6.3. Monolith L-17, total stress distribution normal operating case.

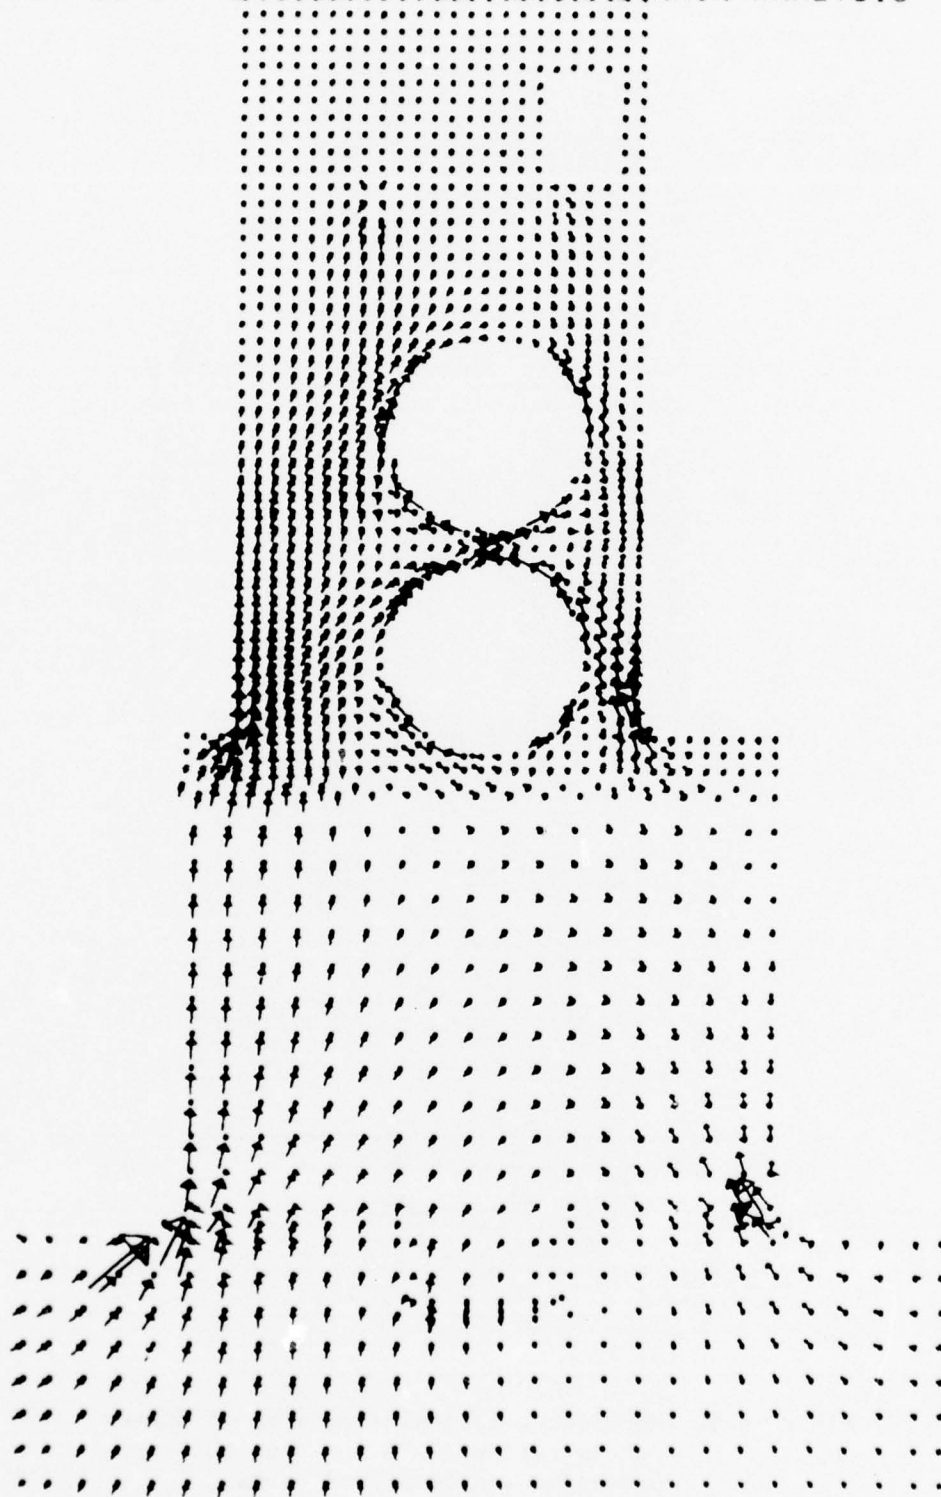
Figure 6.4. Total stress distribution L-17 dewatered.

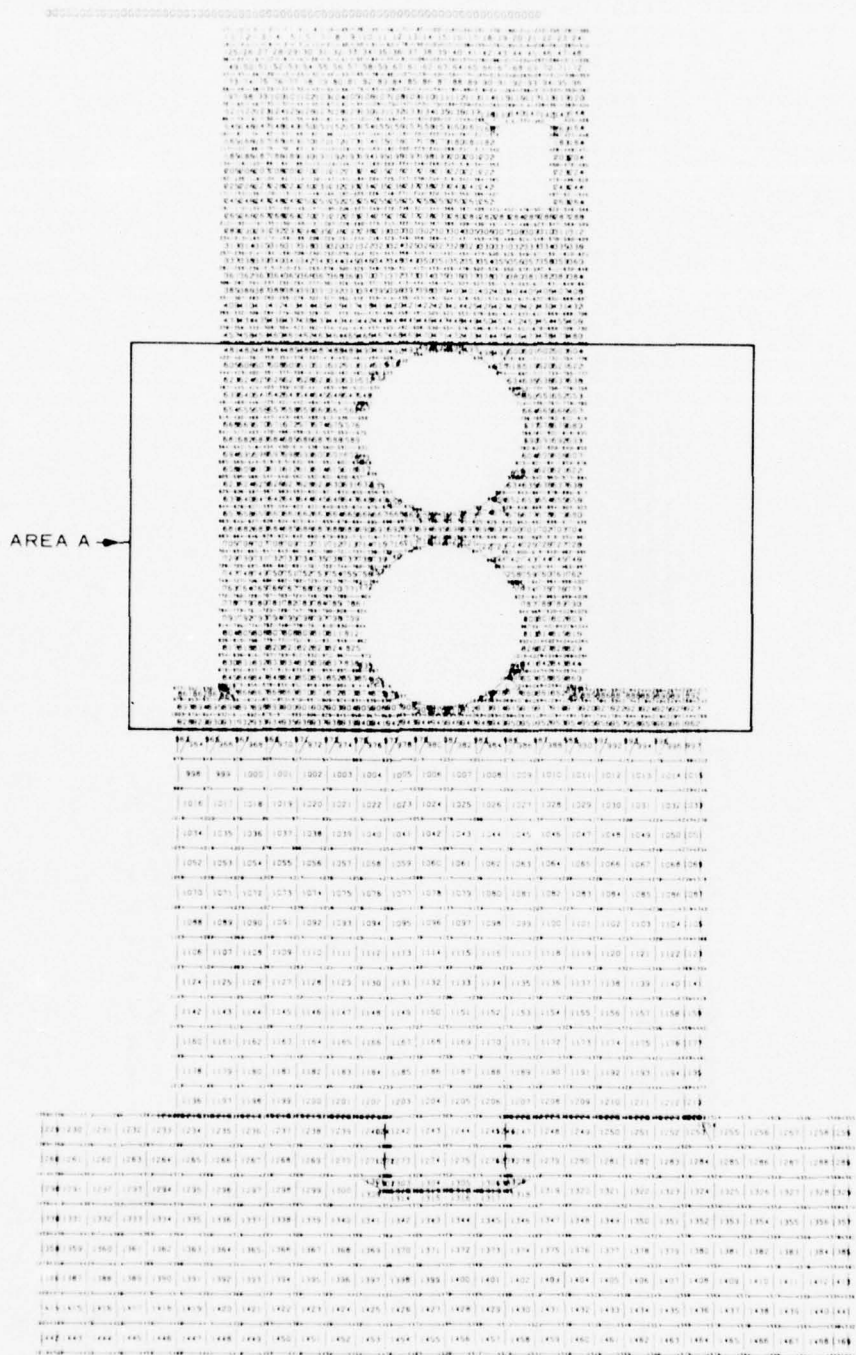
Figure 6.5. Monolith L-17 depicting area of stress concentration ("A") for both the normal operating and dewatered cases.

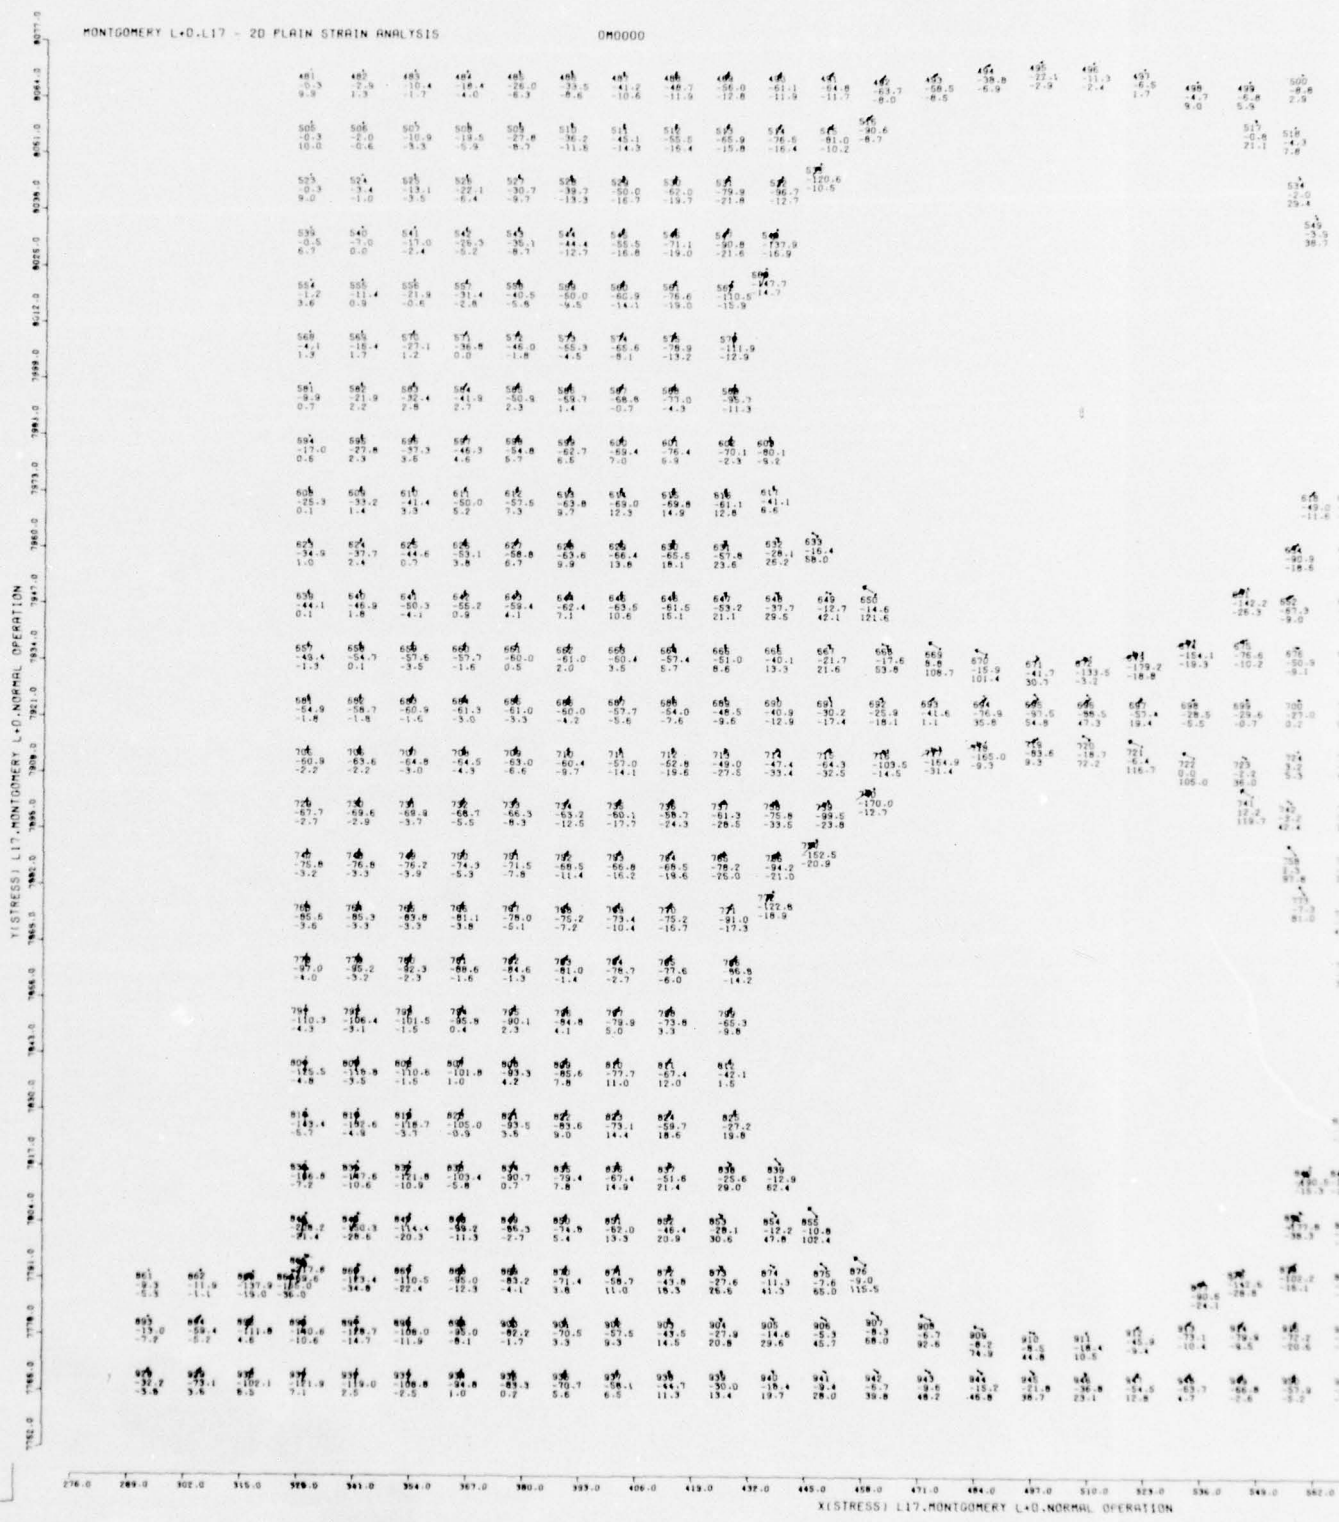
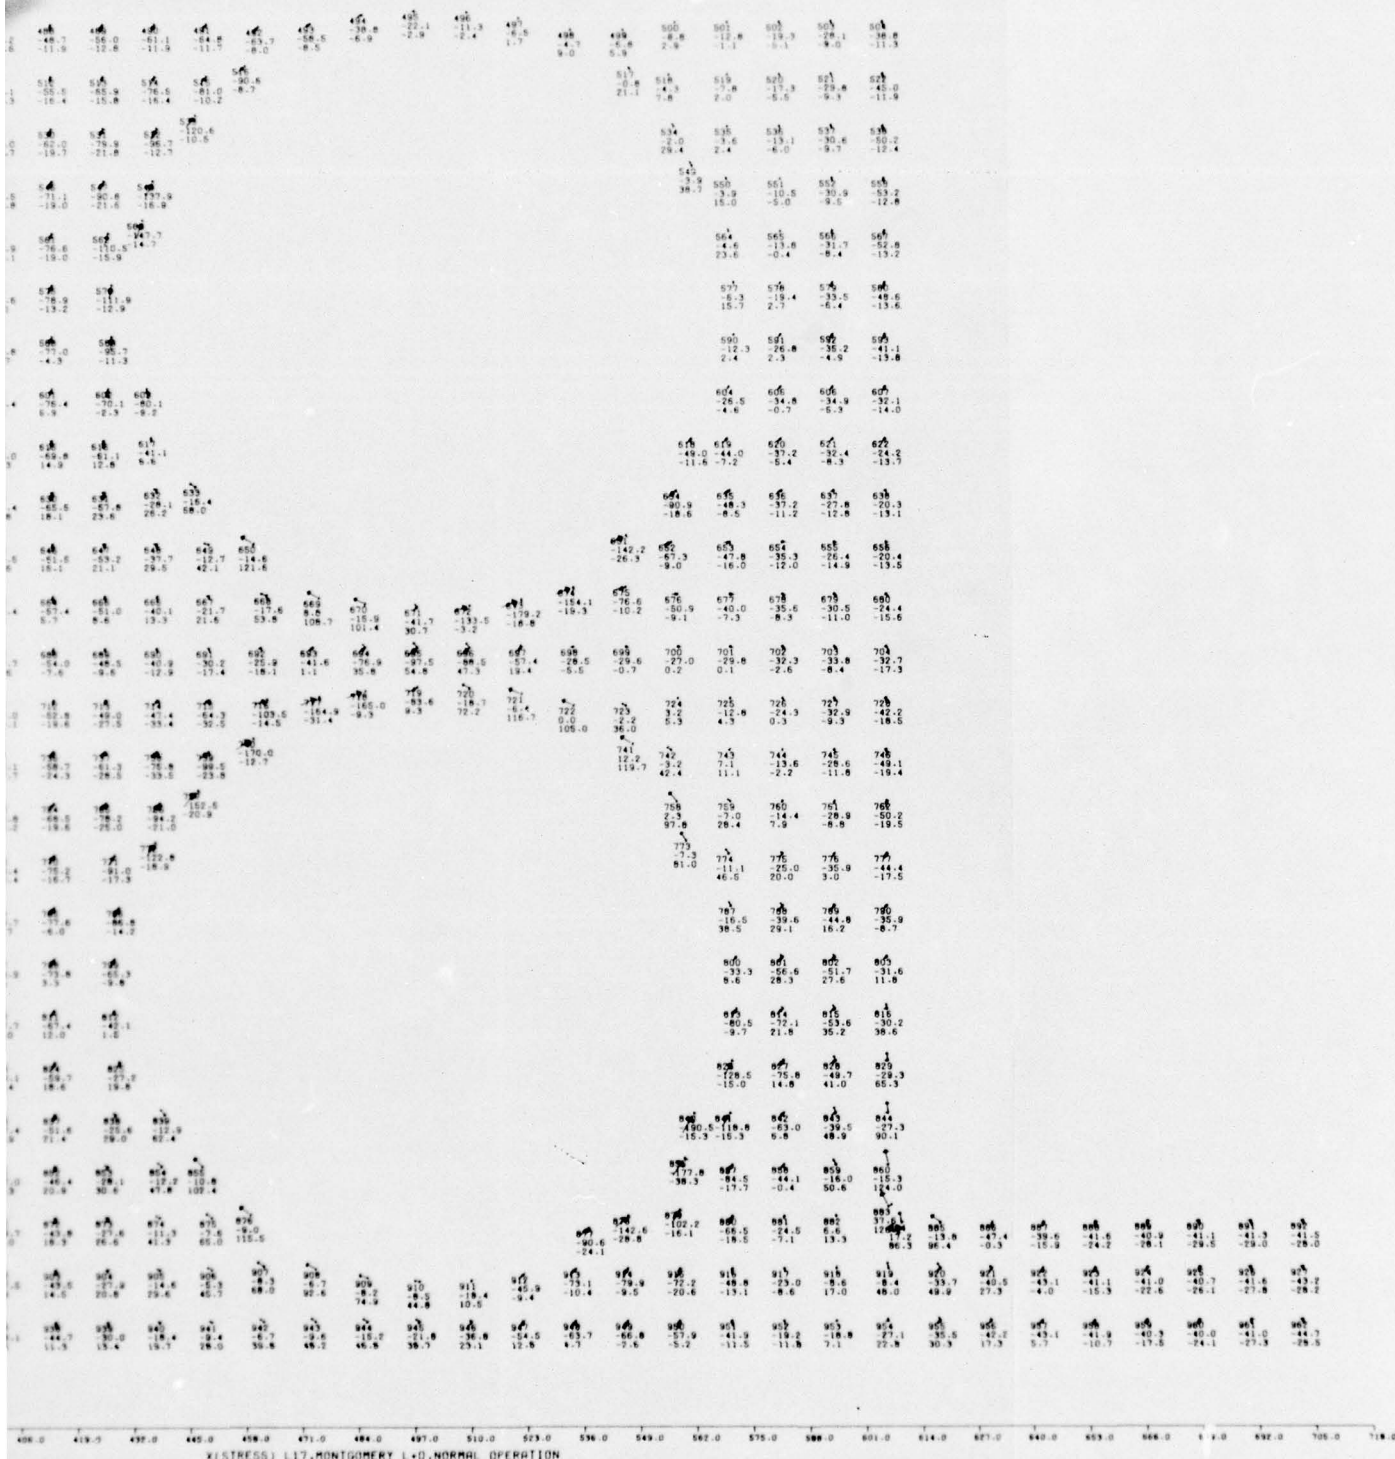
Figure 6.6. Monolith L-17, area of stress concentrations as by area "A" normal operating case.

Monolith L-17, area of stress concentrations as depicted by area "A" normal operating case.

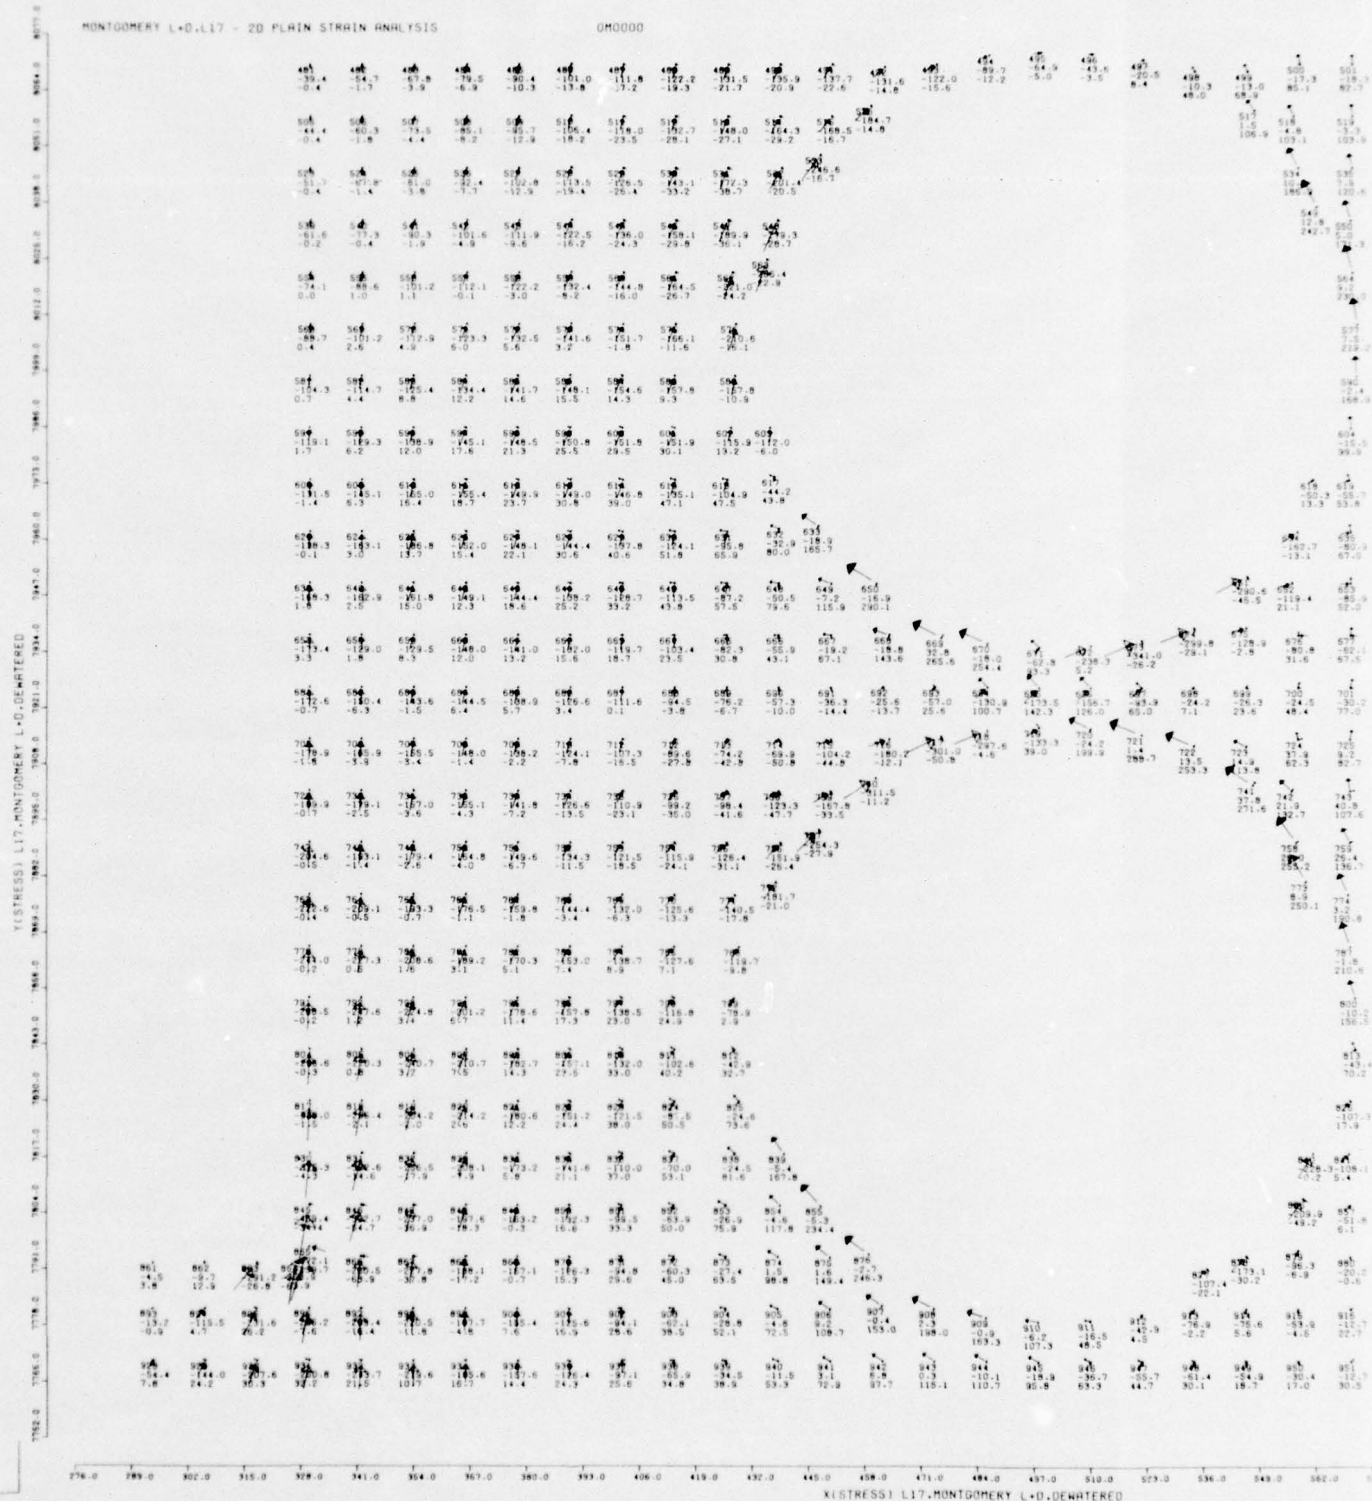
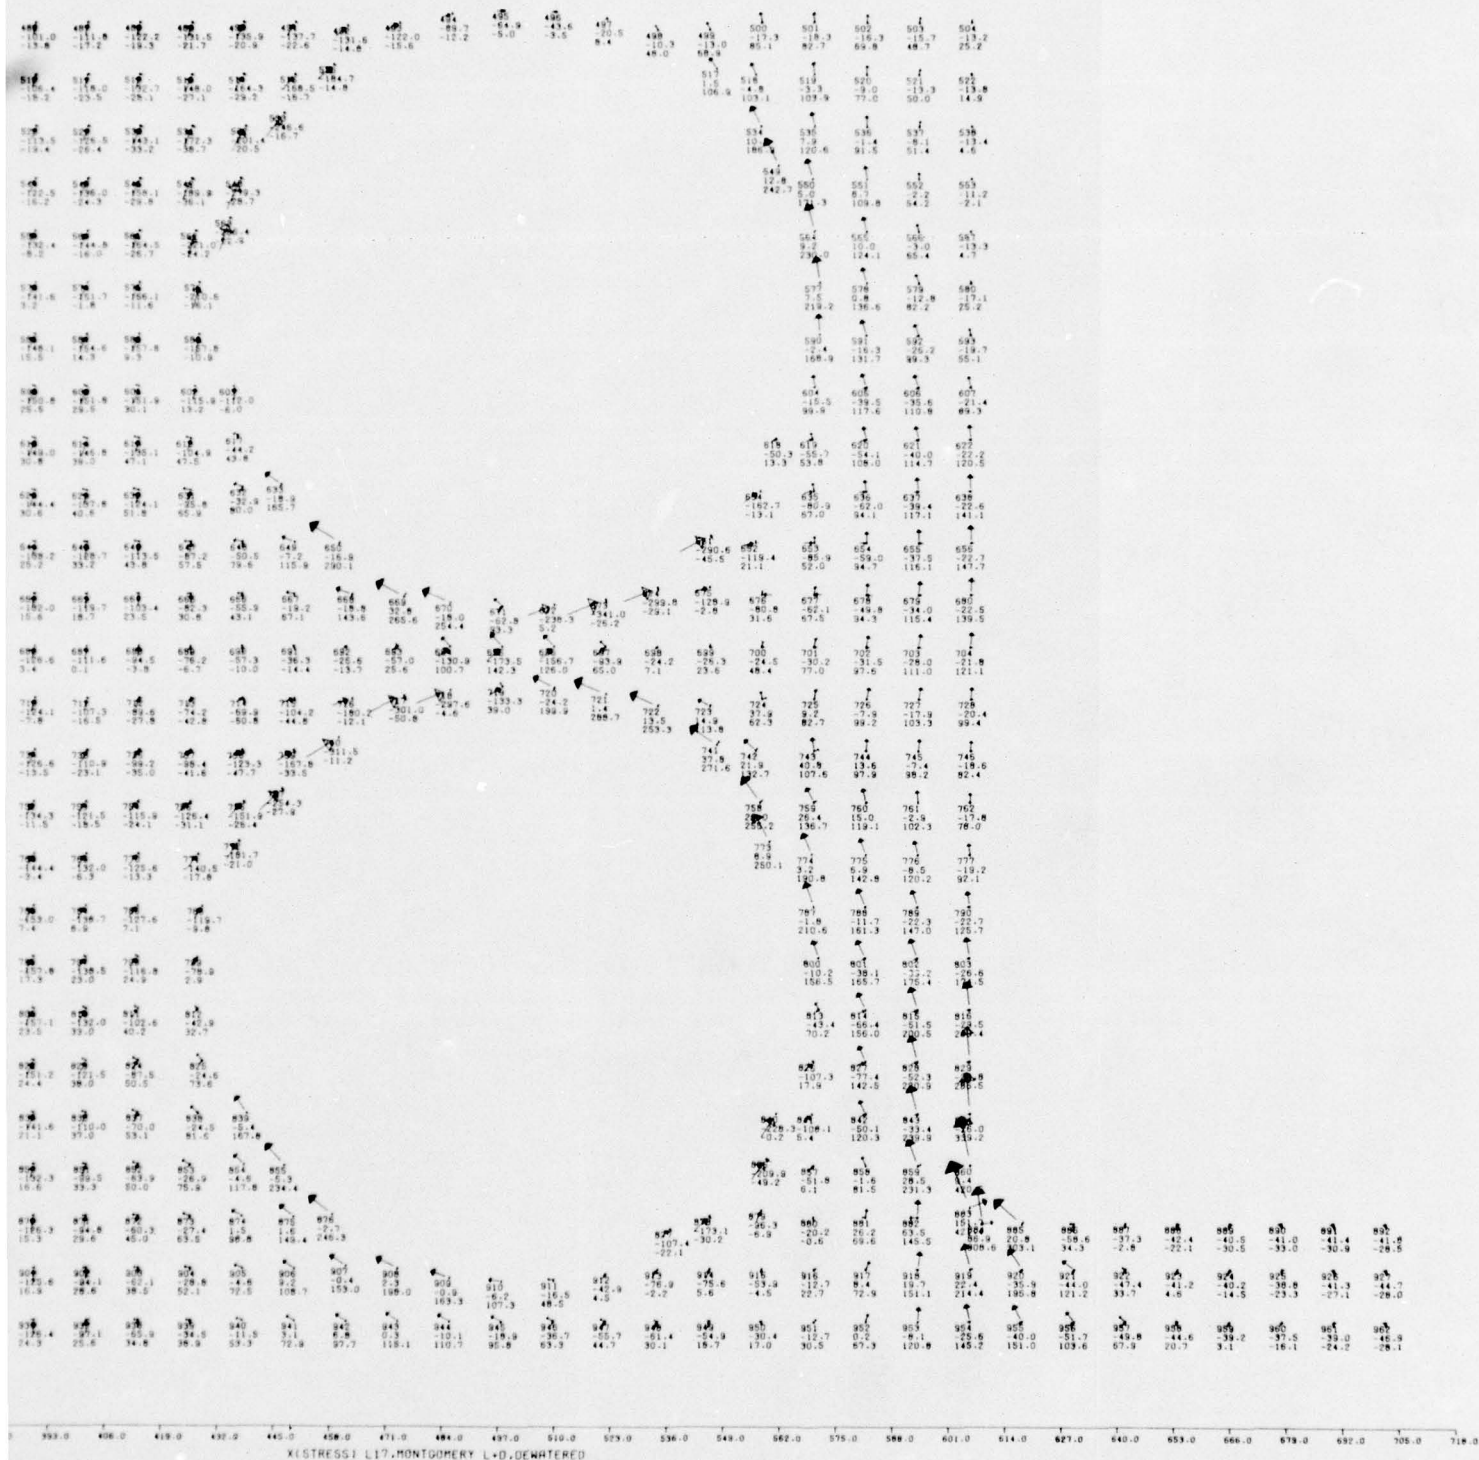
Figure 6.7. Monolith L-17, area of stress concentrations as by area "A" dewatered case.

Figure 6.7. Monolith L-17, area of stress concentrations as depicted by area "A" dewatered case.

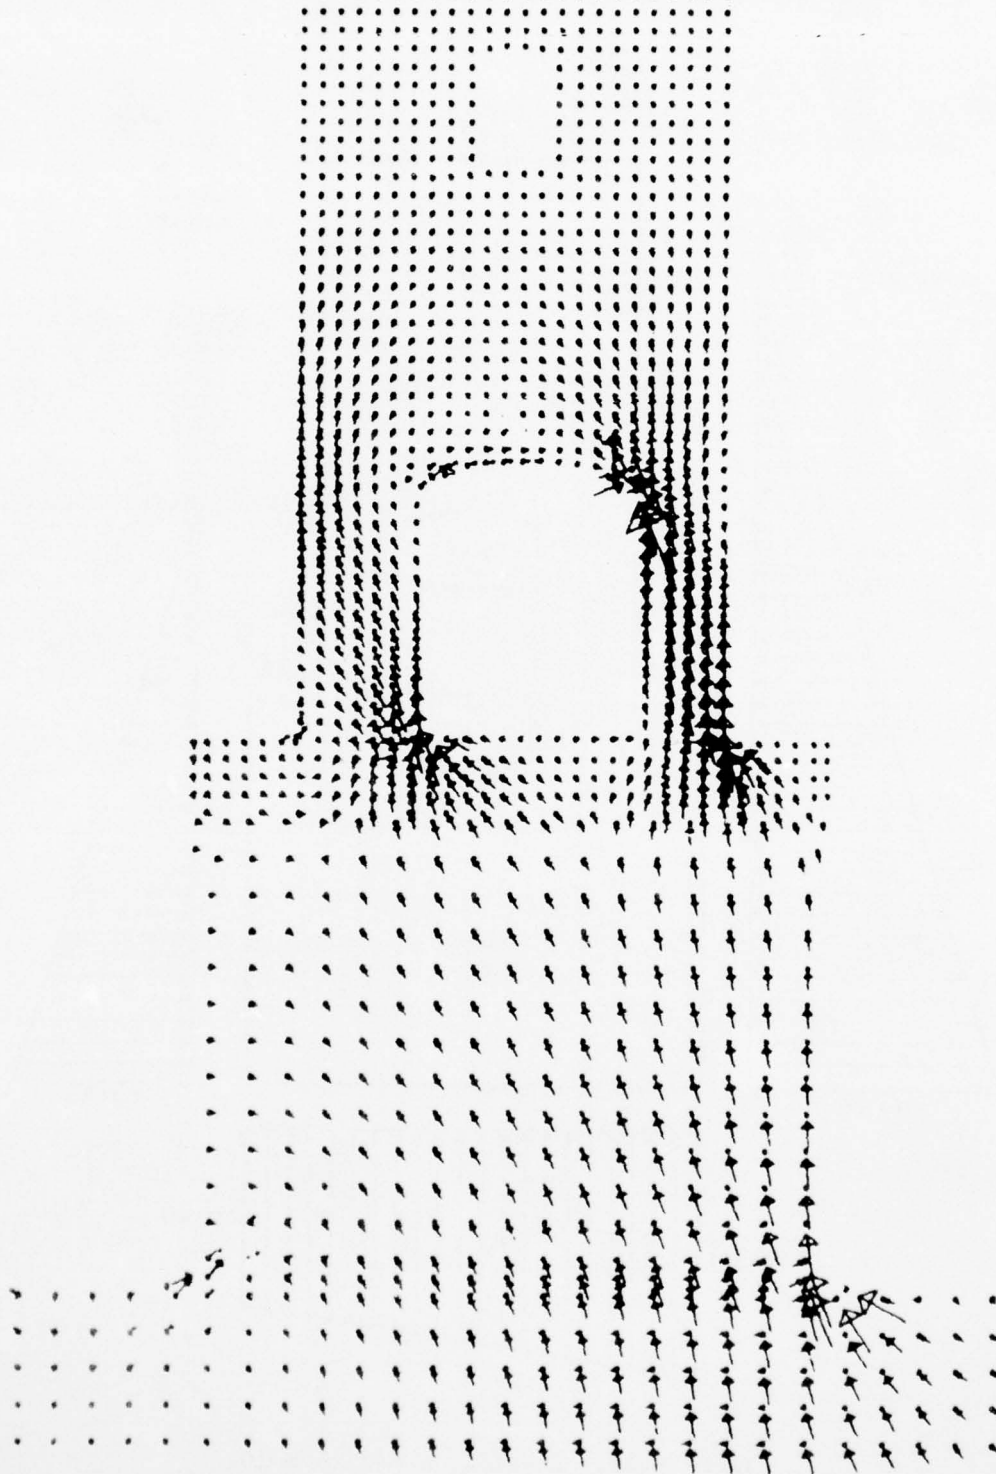
6.19 The loadings for monolith M-10 are given in Figure 6.12. The total stress plot for the normal operating case is given in Figure 6.13. The monolith section depicting the areas ("C" and "D") of stress concentration is given in Figure 6.14. The depicted areas of stress concentration are given in Figures 6.15 and 6.16. Monolith M-10 does not have the impact load applied and the tensile stresses can be seen to be decreased considerably. The maximum tensile stresses are approximately 130 psi and the maximum compression about the same which is much lower than those present when boat impact loads are applied.

Figure 6.13. Monolith M-10, total stress distribution normal operating case.

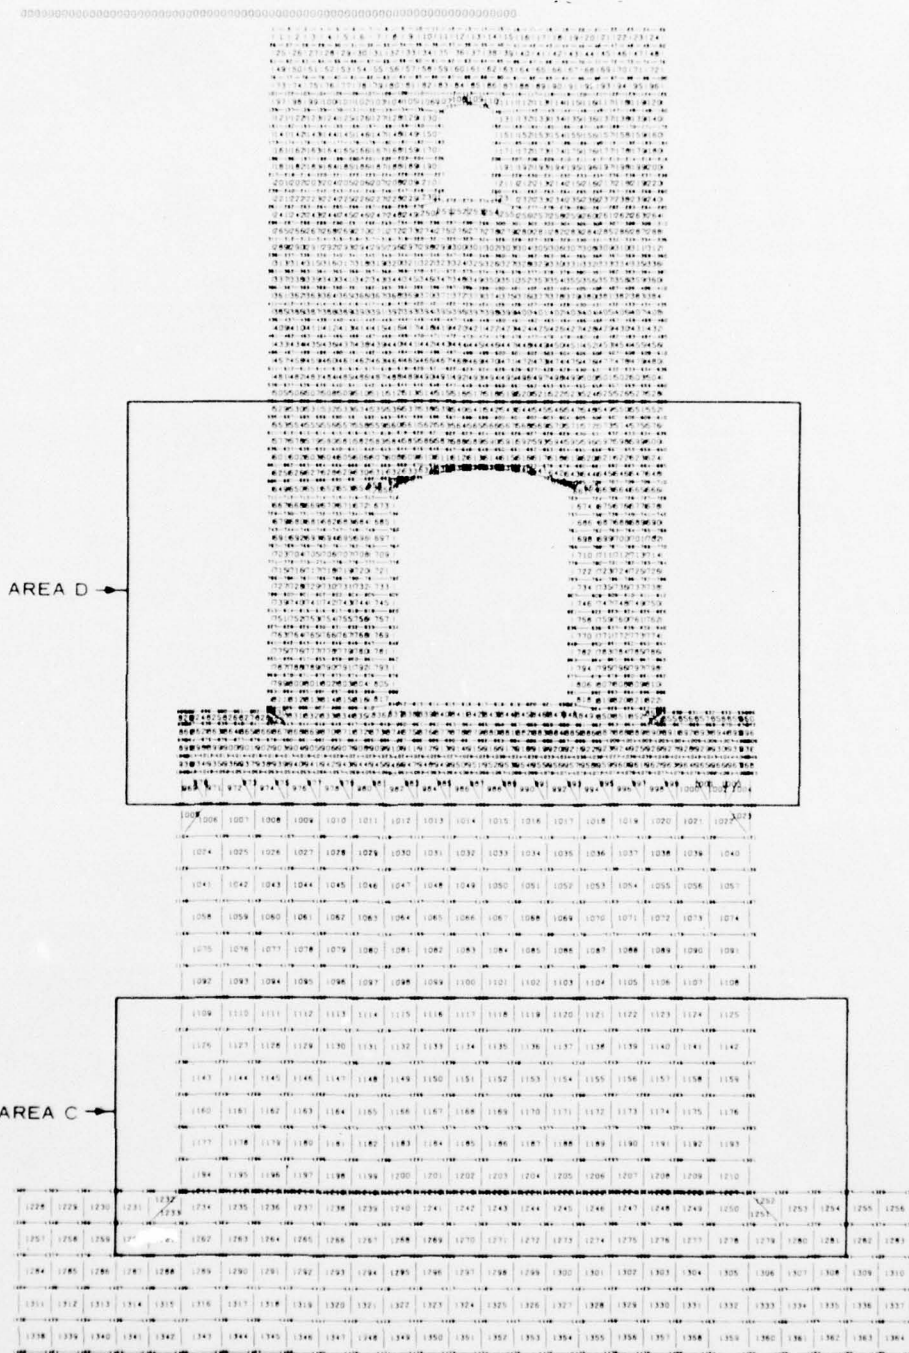
Figure 6.14. Monolith M-10 depicting areas of stress concentration ("C" and "D") for the normal operating case.

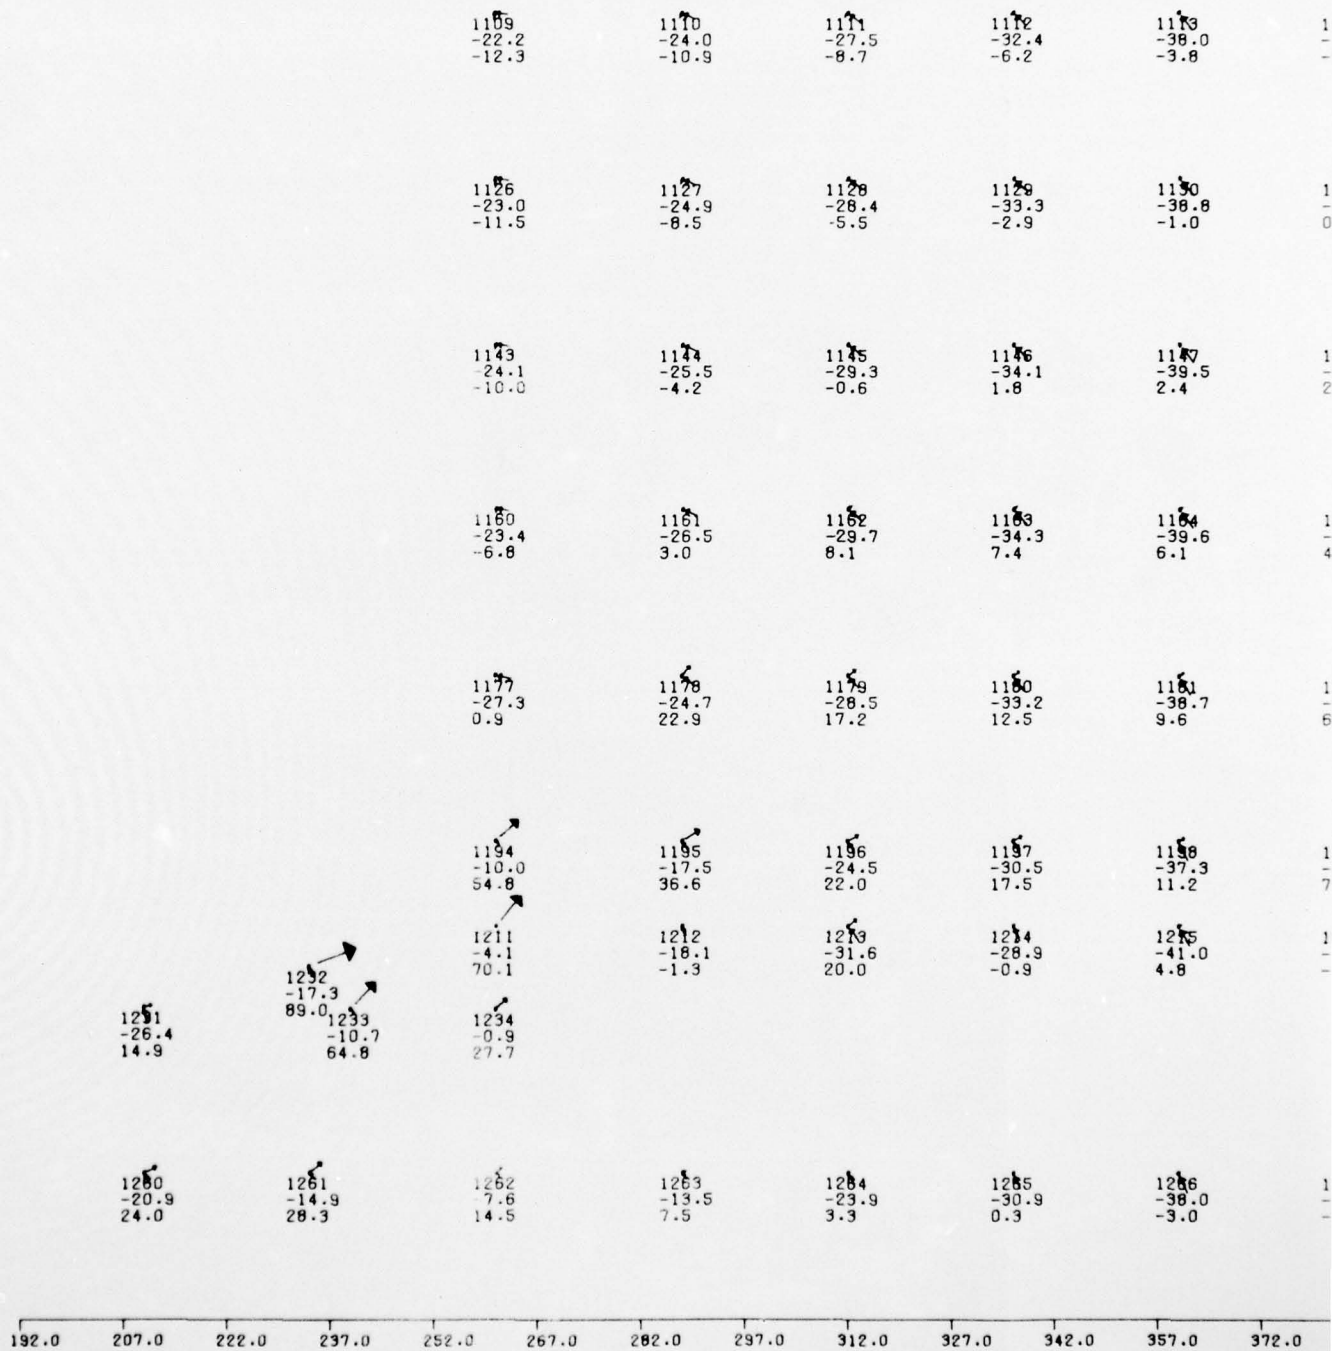
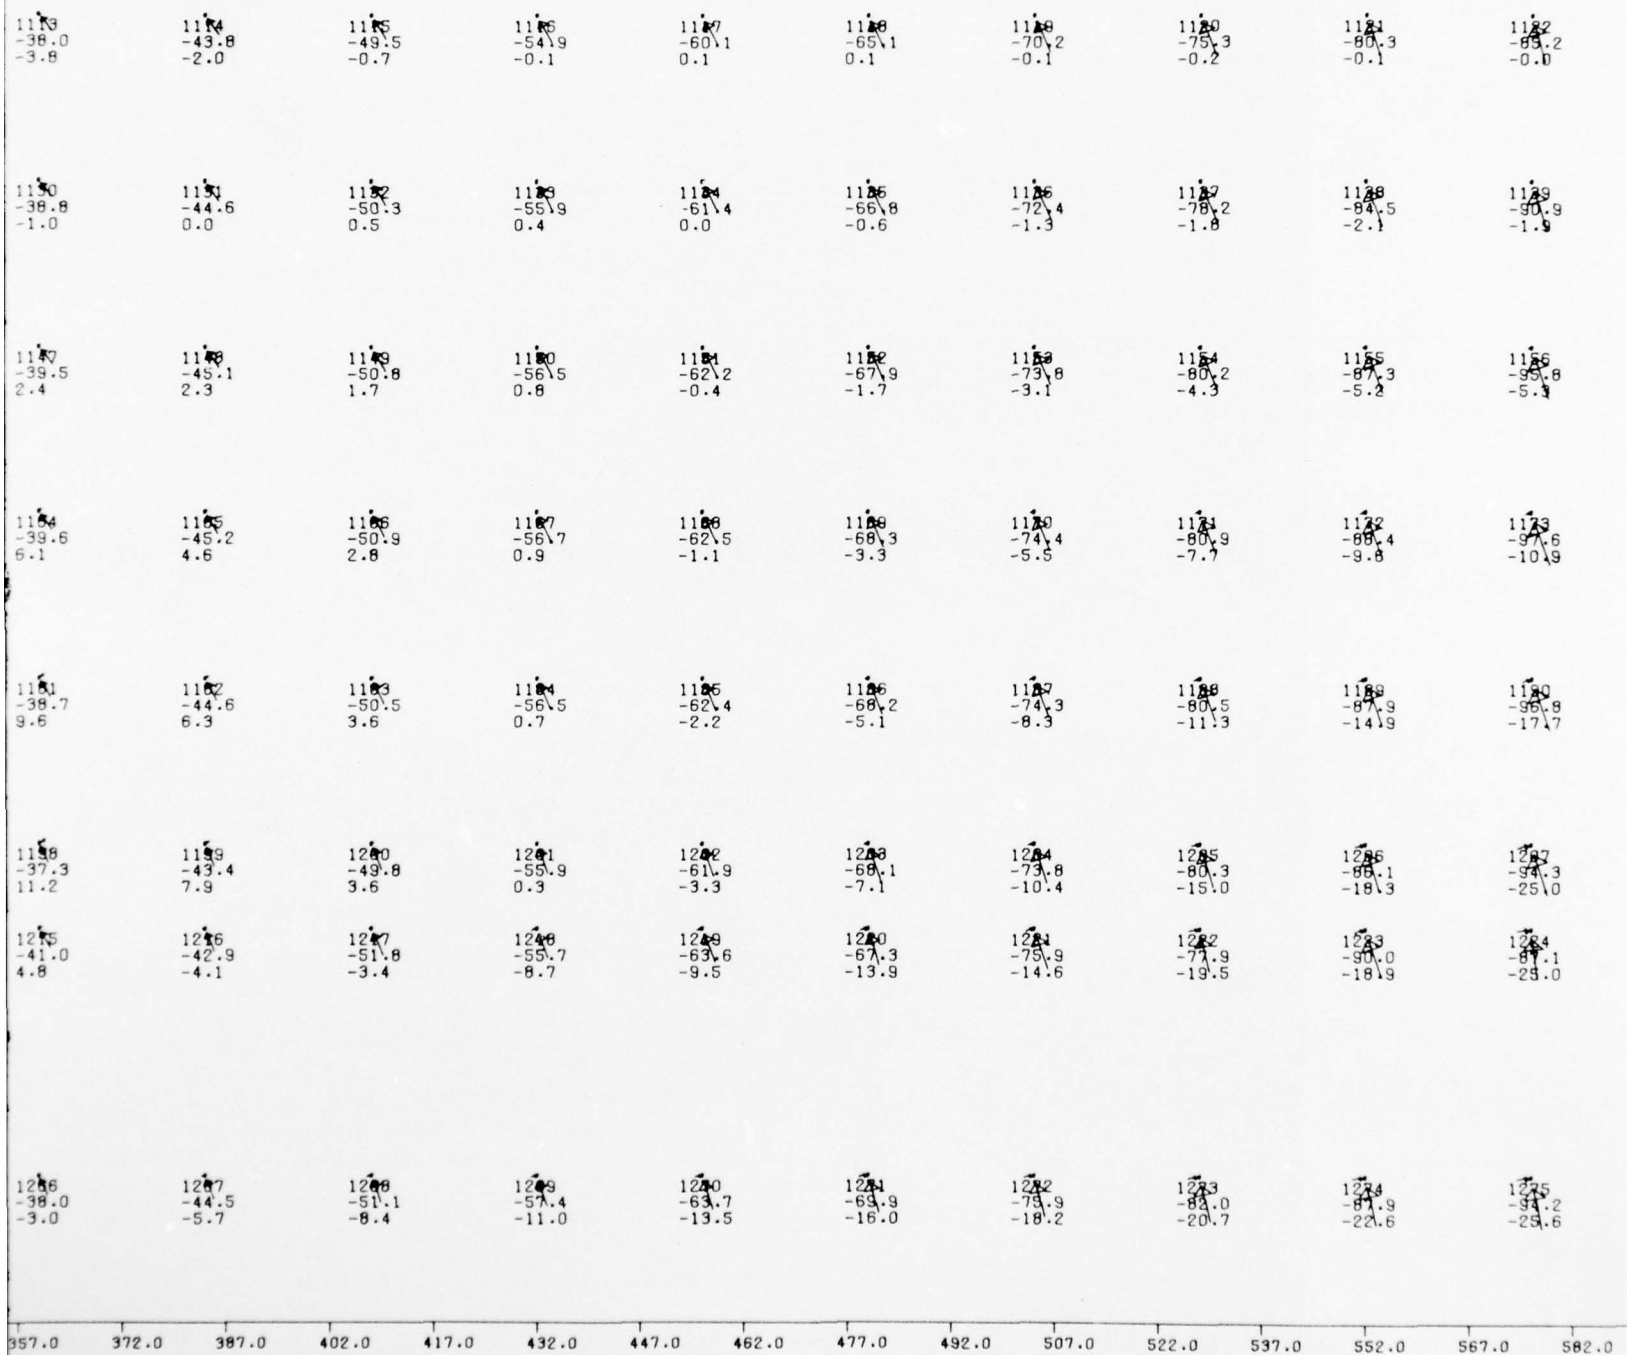
Figure 6.15. Stress concentration as depicted by area "C."

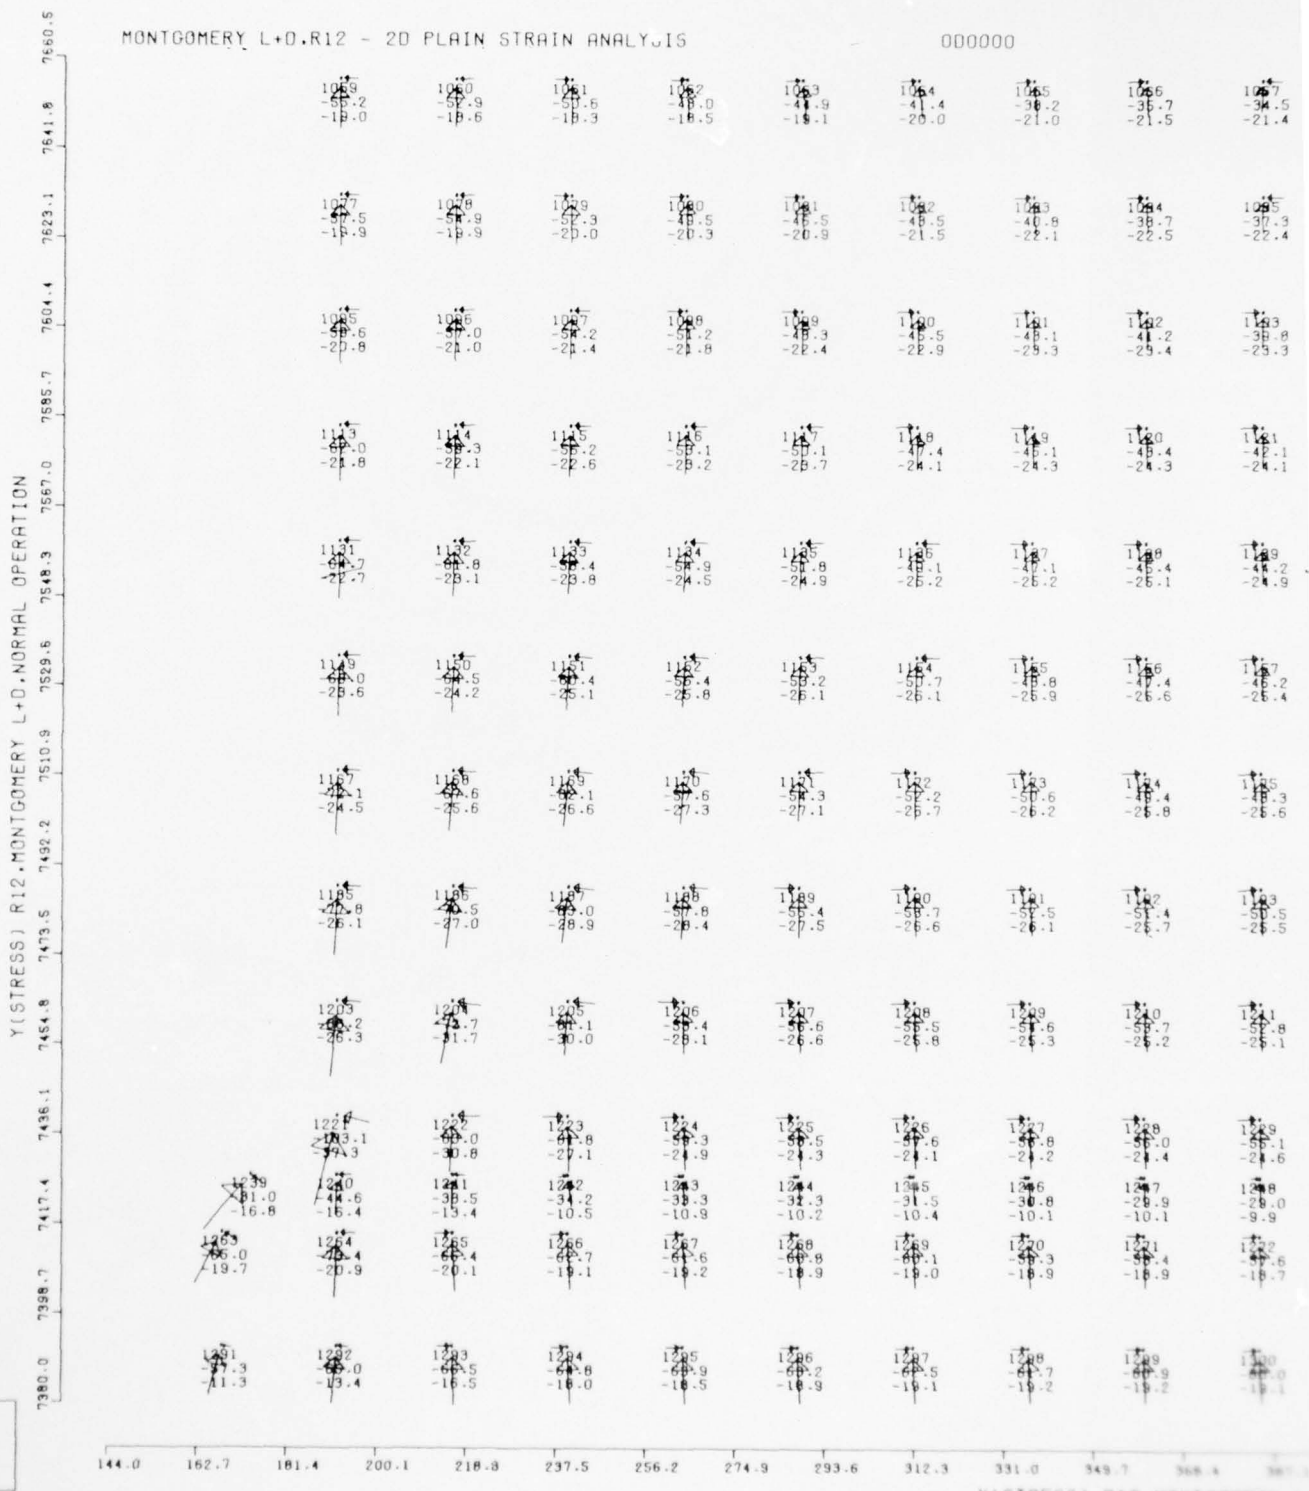
areas of stress concentration are given in Figures 6.20 and 6.21. The stresses due to gate and other loadings do not produce excessive stresses in this monolith. The cracking in this monolith is small and is at discontinuities or cutouts.

Figure 6.20. Stress concentrations

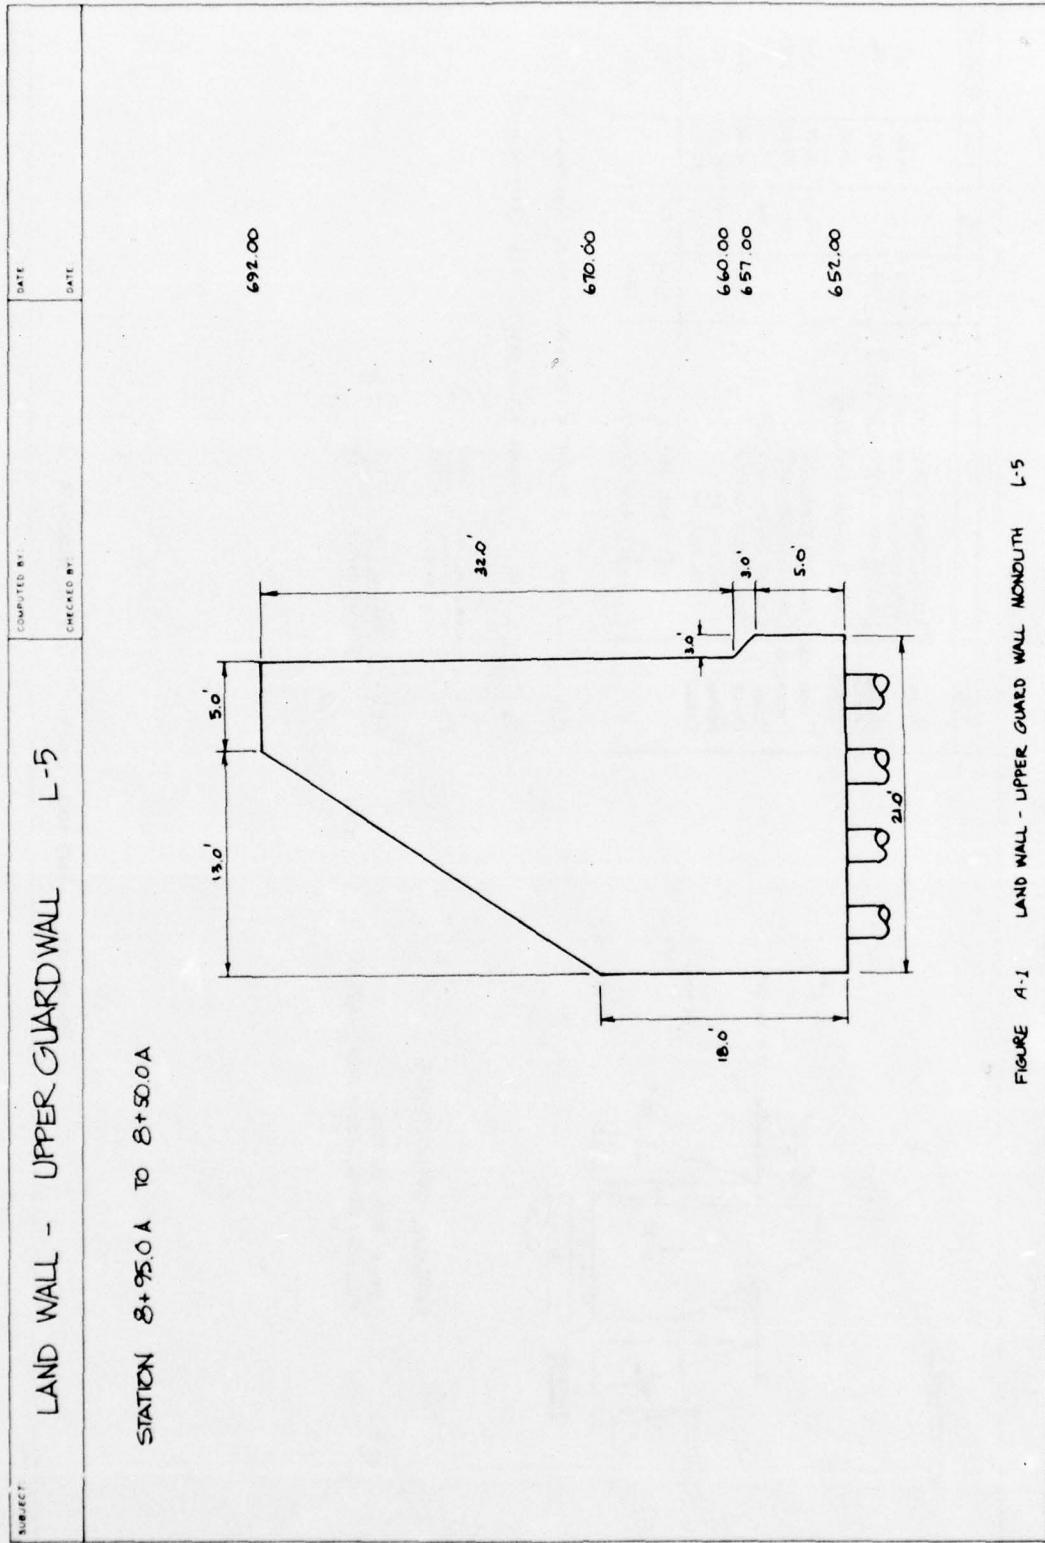
FIGURE A-1 LAND WALL - UPPER GUARD WALL NONDUTCH L-5

$FS_1 = \frac{\sum \text{STABILIZING M}}{\sum \text{OVERTURNING M}} = \frac{1377}{738} = 1.87$

$FS_2 = \frac{\sum \text{STABILIZING M}}{\sum \text{OVERTURNING M}} = \frac{1290}{766} = 1.68$
